SUSQUEHANNA RIVER BASIN  
DALTON RUN, LACKAWANNA COUNTY  
PENNSYLVANIA

GLENBURN POND DAM  
NDI ID NO. PA-00371  
DER ID NO. 35-1

PHASE I INSPECTION REPORT  
NATIONAL DAM INSPECTION PROGRAM

PHASE I INSPECTION REPORT  
NATIONAL DAM INSPECTION PROGRAM  
BRIEF ASSESSMENT OF GENERAL CONDITION  
AND  
RECOMMENDED ACTION

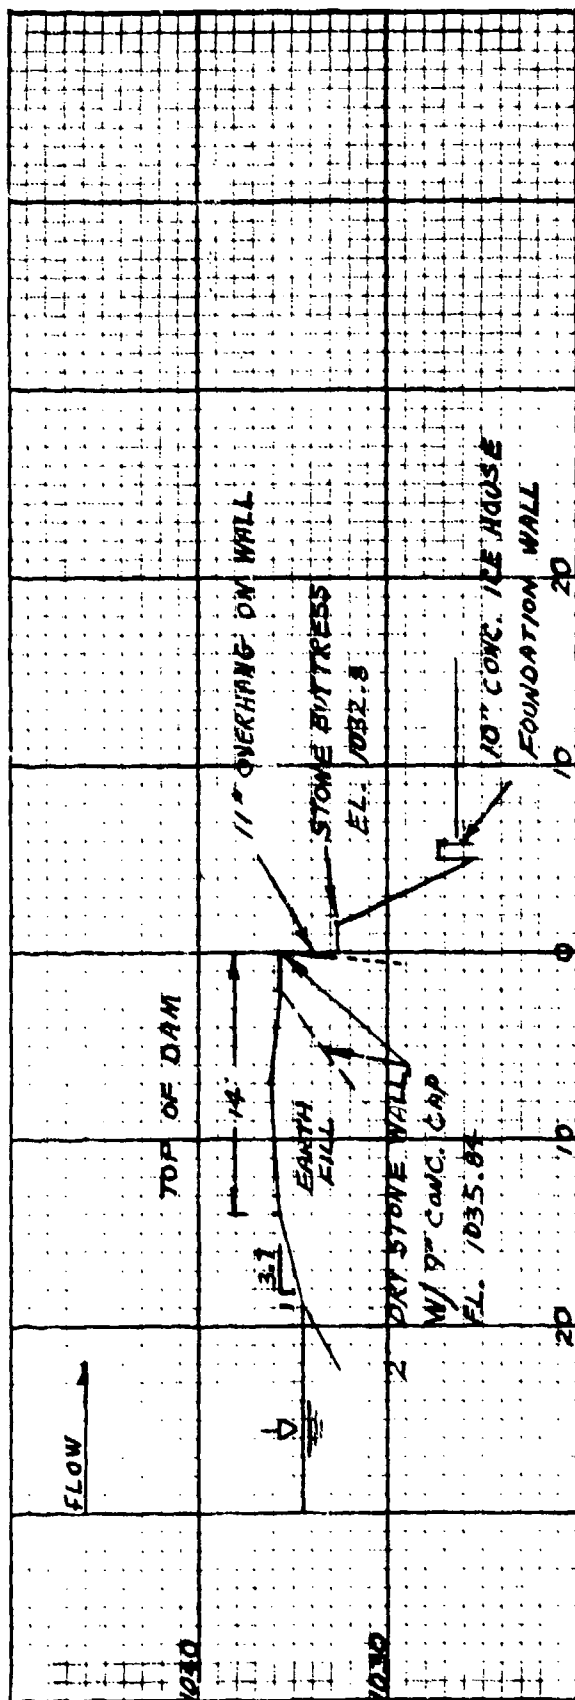
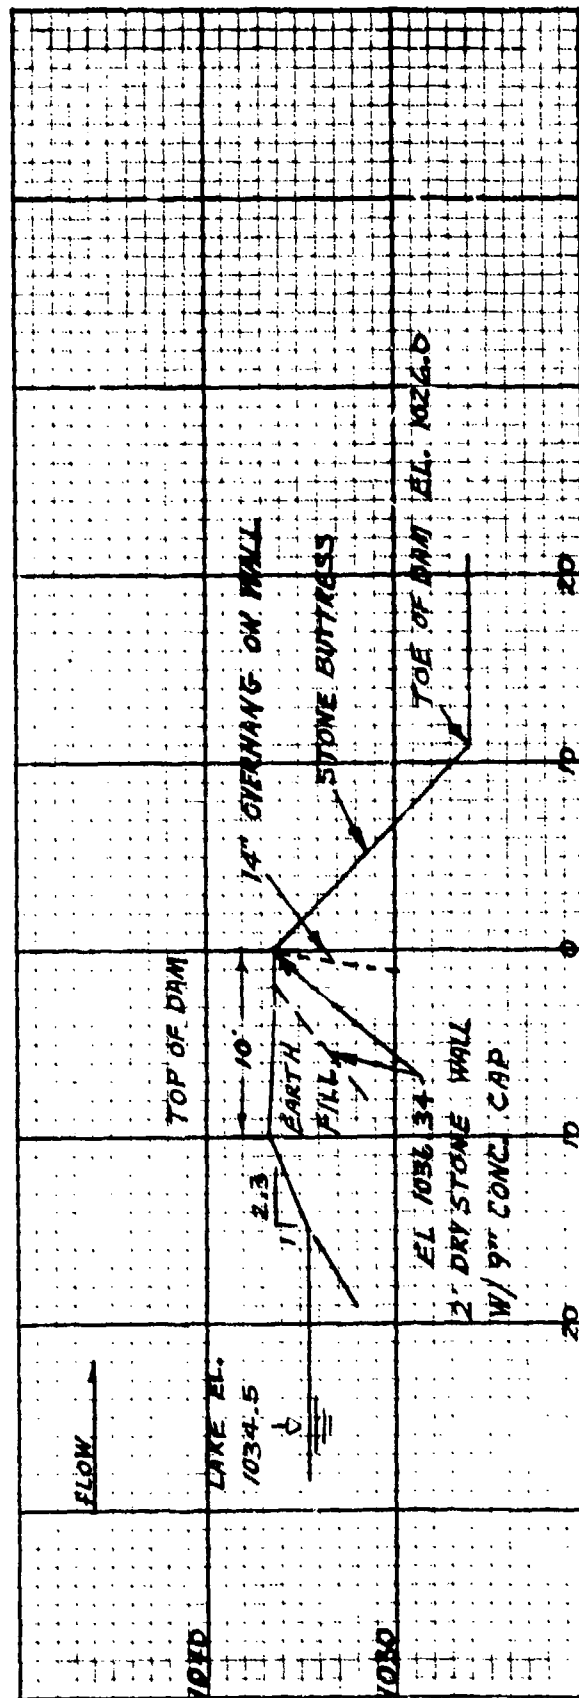
TYPICAL DAM SECTIONS

b. Dam: Observations made during the field inspection reveal that the earth and dry stone masonry dam is in poor condition. The dam is reported to be more than 127 years old. The top surface of the dam slopes down from both abutments to the spillway walls, as illustrated on Exhibit A-2. The downstream vertical dry stone wall bulges downstream and overhangs 14 inches on the right half and 11 inches on the left half (see Exhibit A-3, and Photograph 7, Appendix C). The top of the wall is covered with a concrete cap (2' wide and 9" thick) along its entire length. The concrete cap has a 1½ inch wide vertical crack about 22 feet right of the spillway near the maximum bulge point (see Exhibit E-1). The downstream wall is supported by stone buttresses, as shown in Exhibits A-1, A-3 and photograph 3, Appendix C. Part of the left buttress is wedged between the vertical stone wall and the 10-inch wide concrete foundation wall of an abandoned ice house (see Exhibits A-1 and A-4). The buttress and stone wall are constructed with "one and two man" sandstone boulder slabs. The top 25 to 50 percent of the buttress stones near the spillway have been displaced (probably dumped in the spillway splash area). The spillway splash apron consists of a 3-foot high pile of large boulders, dumped against the vertical wall under the entire spillway length. Scattered leakage points, spurting about 1 GPM, are visible in the stone wall below the spillway (see Photograph 2, Appendix C). A point source leak of about 100 GPM is located at the left toe of the right buttress, about 22 feet downstream of the dam (see Photograph 4, Appendix C). There is no accumulation of fines in the leakage area. Brush and trees to 10 inches in diameter are growing in the stone wall and on the earth embankment slopes.

The maintenance of the dam is inadequate. The missing buttress stones should be replaced, the trees and brush should be removed from the dam and the owner should institute regularly scheduled maintenance inspections. The leakage flows should be monitored to detect any changes in quantity and turbidity. Findings and subsequent maintenance and repair work should be documented. A surveillance program should be developed to detect any adverse conditions at the dam and a method of emergency drawdown should be instituted. An emergency warning system and a formal evacuation plan should be prepared to evacuate the downstream population if adverse conditions develop at the dam.

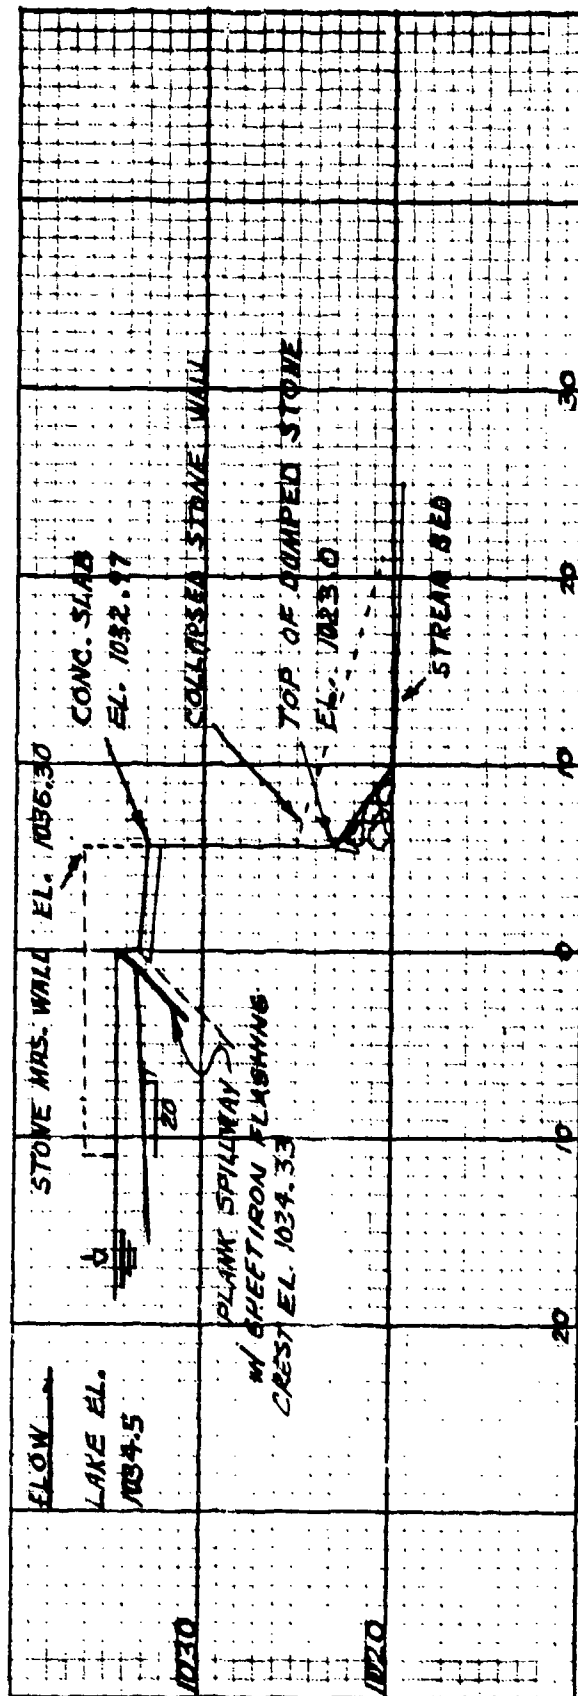
**SPILLWAY SECTION**

(a) Spillway: The 51-foot long spillway acts as a sharp-crested weir under low flow conditions and as a broad-crested weir under high flow conditions. The sharp-crested weir is constructed with lapped 2 x 12" planks, 48" long, covered with sheet iron flashing, extending 12-inches above the downstream spillway slab. The broad-crested weir is a 5-foot wide concrete spillway slab that is 3.3 feet below the top of the spillway side walls. These walls curve at the upstream end to form an approach channel about 58 feet wide at a distance of about 15 feet upstream of the spillway drop (see Exhibit A-1). At the base of the vertical drop, large dumped stone boulders serve to dissipate energy and protect against undercutting of the vertical wall (see Exhibit A-4 and Photograph 3, Appendix C).
